**Flood Control Project Maintenance
Levee Inspections**
LMA District Cover Sheet
Spring 2018 Levee Inspection Results

Reclamation District No. 0070 Meridian

Spring 2018 Levee Inspection Results

Waterway			Bank	Unit Miles
Unit No. 01 Sutter Bypass			Right	7.92
	Spring (March - May)	Summer (June - August)	(September - November) Fall	Winter (December - February)
Unit Maintenance Rating (Fall Only)				
Date of Inspection	3/15/2018 - 3/15/2018			
DWR Inspector	Bob Duffey			
Accompanied By	Andy Duffey

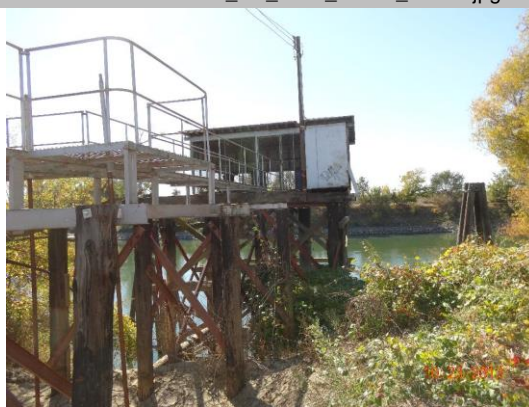
Photo 2 of 3 : UCIP_SP_2018_24230_42855.jpg

Pump located on waterward side.

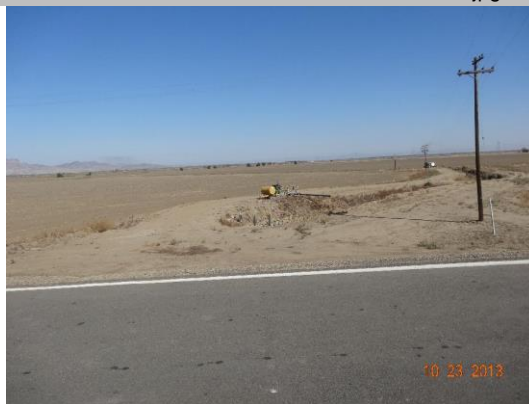
Photo 2 of 3 : UCIP_SP_2018_24231_42863.jpg

View of landward side.

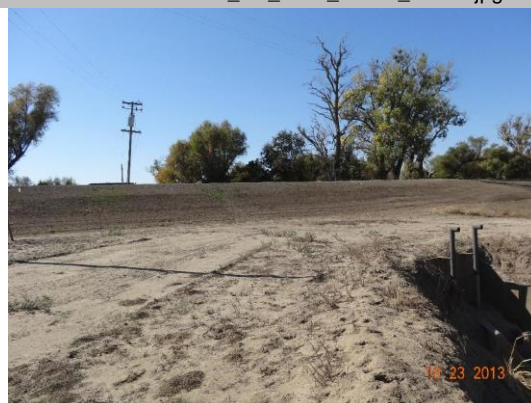
Photo 3 of 3 : UCIP_SP_2018_24231_42860.jpg

Item	DWR UCIP Field Study			39.065285 °	39.065285 °	
				-121.839202 °	-121.839202 °	
DWR ID						
Comment Code						
Inspector Comment						
FS_ID:24231 DS_ID:21420 EP_NO: N/A Repair Type: Non-Urgent Crossing Status: Found UCIP Comments: No daylight visible on landward side. Pipe was visible on waterward side. Need to contact owner to determine status of crossing. This crossing is referenced in the USACE Periodic Inspection as item USACE_CESPK_MRD2_2012_p_0685. FIELD_STRUCT_DESC: 16-inch steel irrigation discharge pipe through the levee, approximately 15 feet below the crown. Gate valves on the waterside (WS) end. Pumps on the WS. [Additional Reference(s): USACE Sacramento O&M Manual 134, June 1953, (Station 1086+55)]. FS Date: 10/23/2013

View of landward side photo taken from concrete headwall.
